WATER DAMAGE INVESTIGATION

**Department of Children & Families
Shetland Park Office Complex
45 Congress Street
Salem, Massachusetts**

Prepared by:
Massachusetts Department of Public Health
Bureau of Environmental Health
Indoor Air Quality Program
September 2018

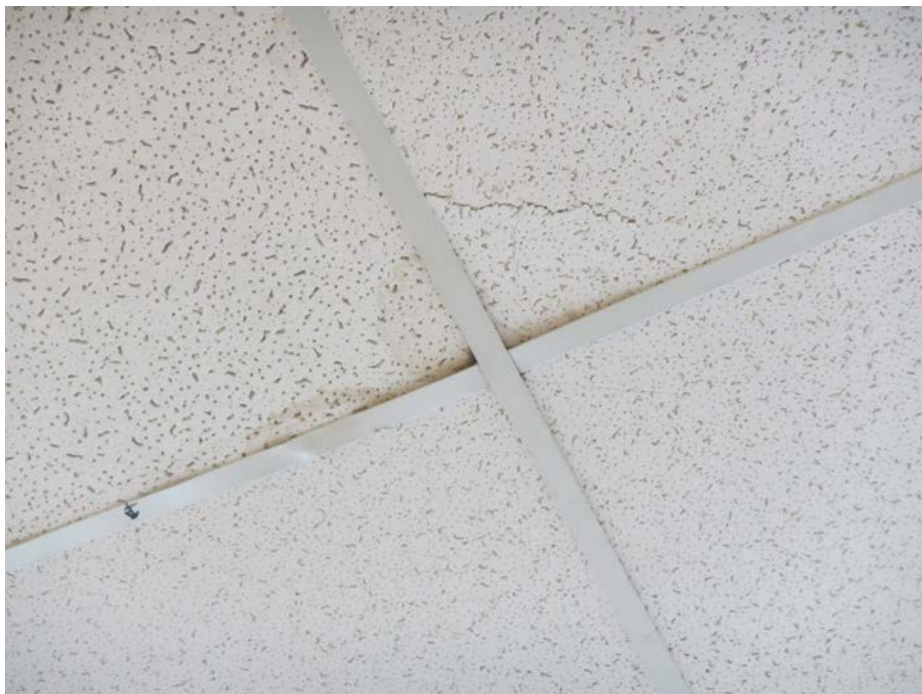
Picture 2

At the time of this assessment, most water-damaged ceiling tiles had been replaced. Leaks will likely persist until these older, inefficient HVAC units are replaced in the coming weeks as reported by Shetland Property management. Although occupants did report musty odors in the past, BEH staff did not observe any visible mold or associated odors during this inspection.

Water-stained ceiling tiles that were recently replaced (note marking on frame)

2. Use EPA recommended drying techniques on porous items to fully dry them within 24-48 hours should future leaks occur.
3. Discard any porous items (e.g., carpeting, cardboard, ceiling tiles) that were previously water-damaged and not dried within the recommended 24-48 hour time frame.

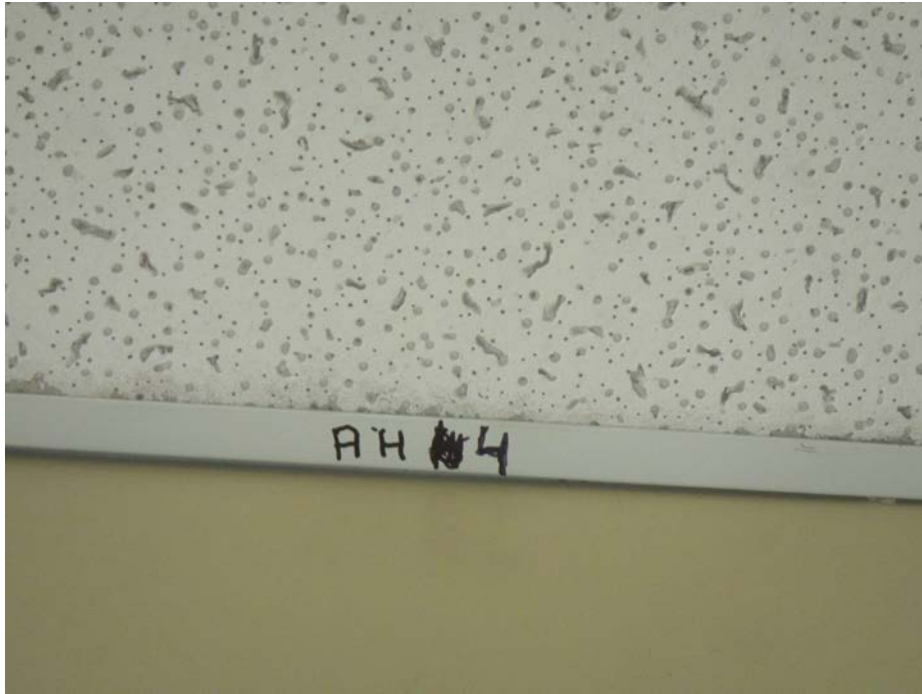
Picture 3

Marking on ceiling tile frame (for AHU) in vicinity of an active leak

1. Continue with plans to install newer HVAC systems that will adequately handle the needs of the DCF space. Inspect drip pans for proper drainage and cooling lines for proper insulation to prevent future leaks.

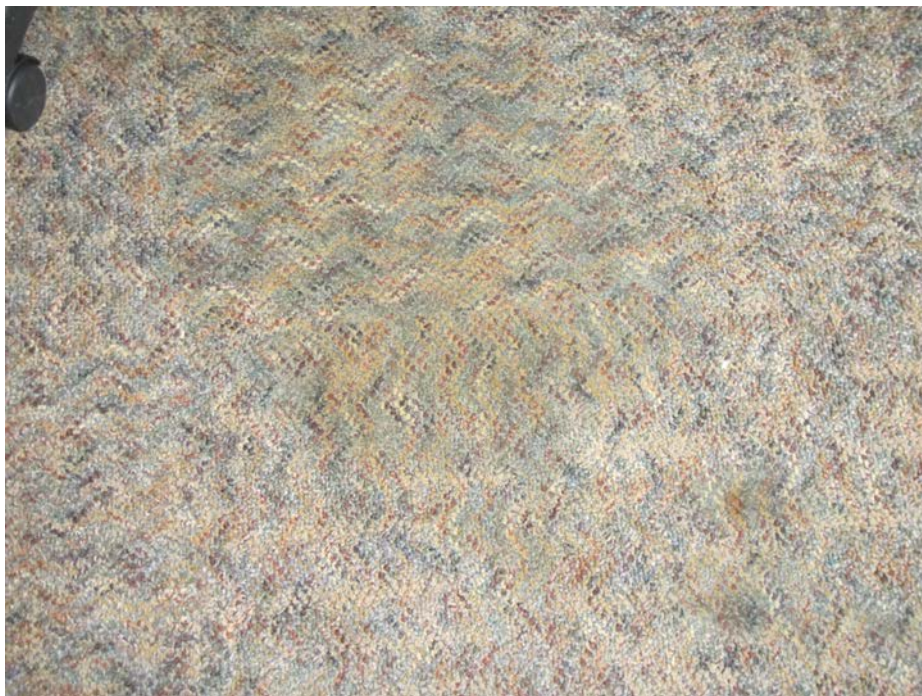
Picture 4

Property management staff reported that the carpet tiles in the DCF space had just been cleaned and plans were scheduled to replace carpet tiles in some areas. Carpets should be vacuumed regularly with a high efficiency particulate arrestance (HEPA) filter equipped vacuum cleaner and cleaned annually (or semi-annually in soiled/high traffic areas) in accordance with Institute of Inspection, Cleaning and Restoration Certification (IICRC) recommendations, (IICRC, 2012). Most modern commercial carpet tiles are synthetic and somewhat mold-resistant

but if the regular HEPA vacuuming is not completed, the dust/debris itself may serve as a reservoir for microbial growth when given chronically moist conditions. If porous carpeting had become mold-colonized in areas not cleaned and properly dried, they cannot be effectively cleaned therefore must be discarded.

Water-damaged/soiled carpet tiles

4. Replace any damaged window gaskets and repair gaps around exterior window frames to prevent further water infiltration.
5. Regularly HEPA vacuum and clean carpeting in accordance with IICRC recommendations (IICRC, 2012).

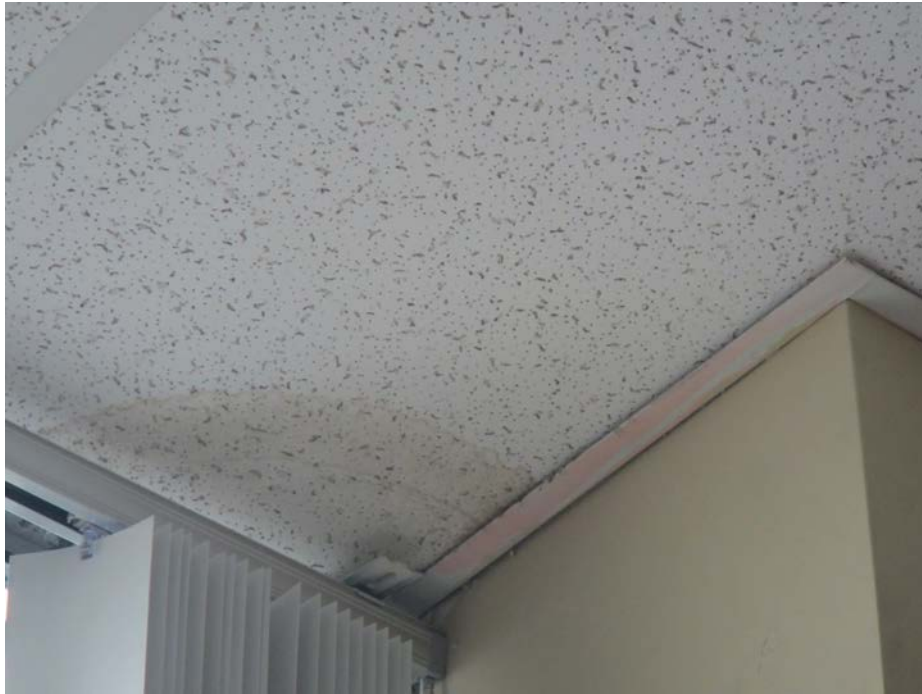
Picture 5

Some occupants that were located near east-facing windows reported that water infiltrates around the window frame regularly following rain events (Picture 5). Some windows in these areas were noted to have dislodged gaskets and/or gaps in the exterior masonry/caulking (Pictures 6 and 7).

Water-damaged ceiling tile adjacent to window

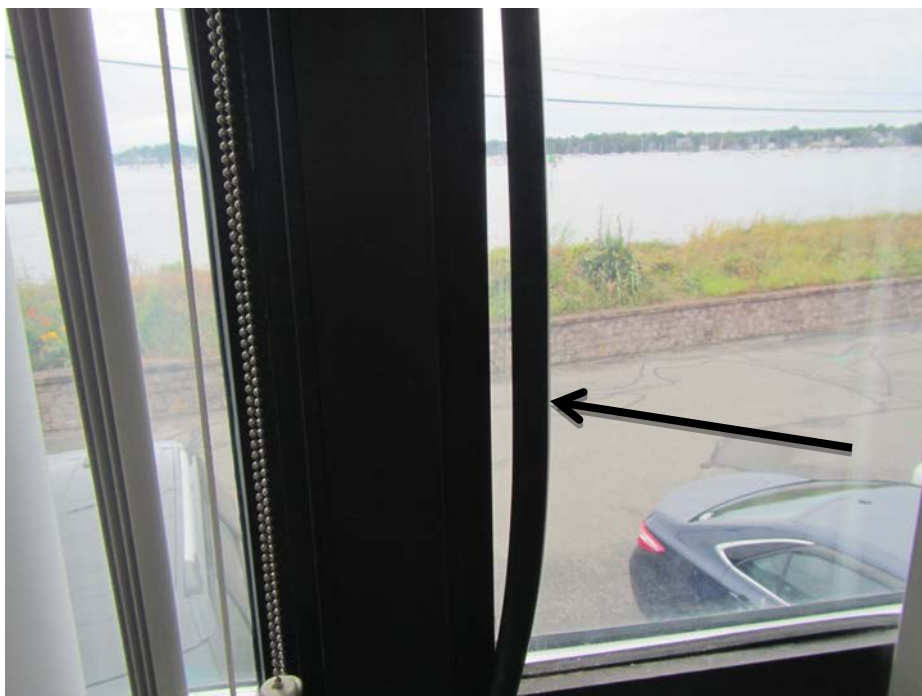
Picture 6

Window gasket dislodged in area of leaks (arrow)

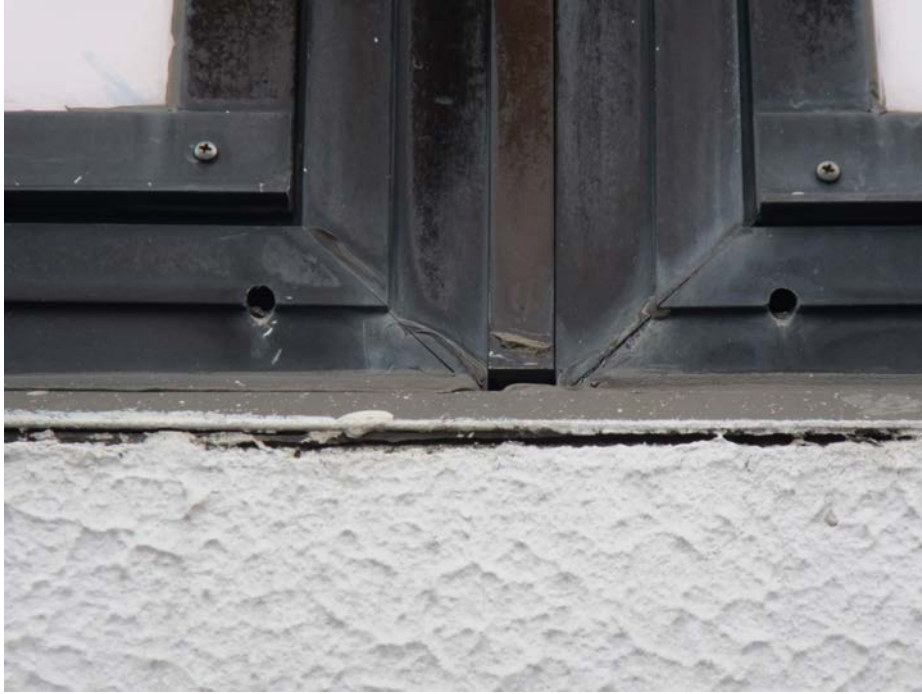
Picture 7

Gaps in stucco and caulking around exterior of window frames
